Memorandum

Date: *August 15, 2014*

Subject: *Oversight Summary Report
CPG Oversight of RM 10.9 Removal Action
Lower Passaic River Restoration Project*

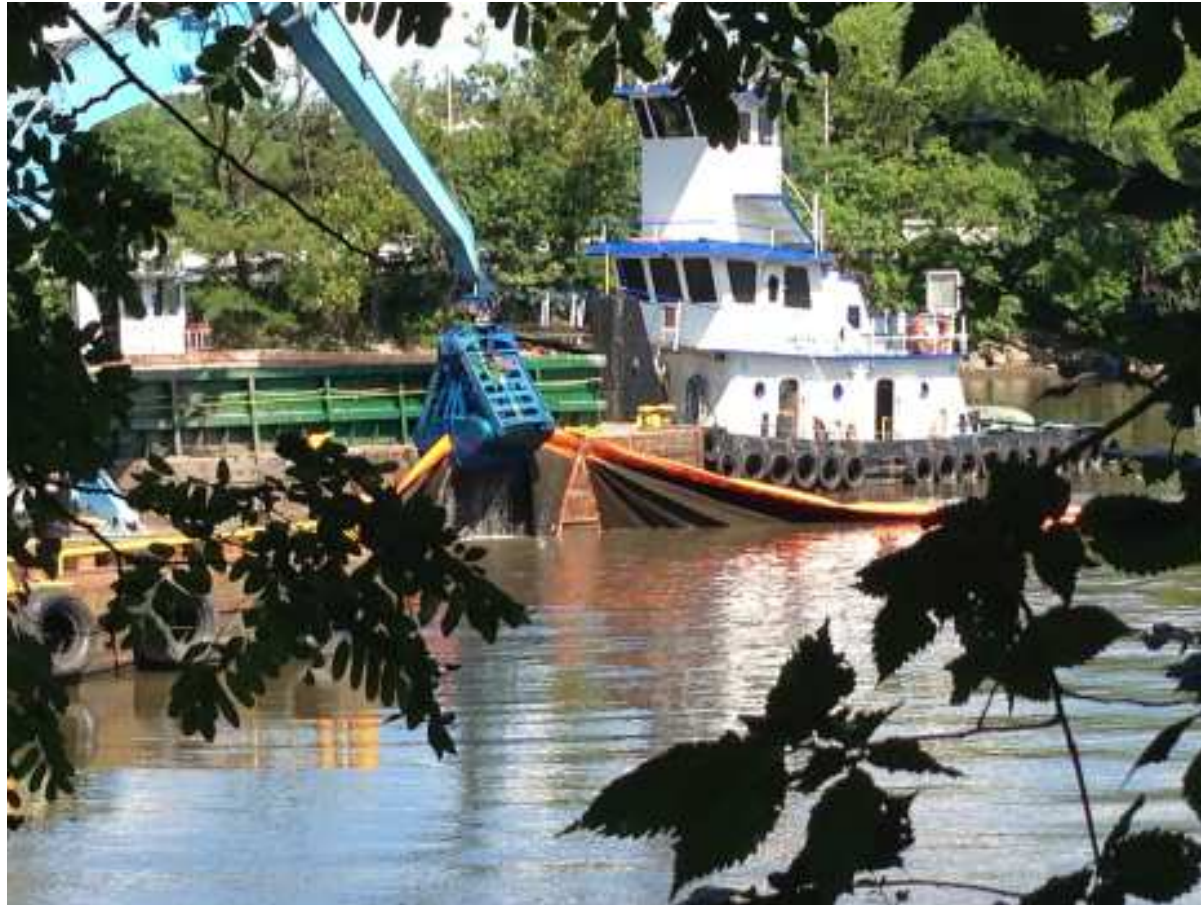
August 15, 2013: Silt Curtain Adjustment

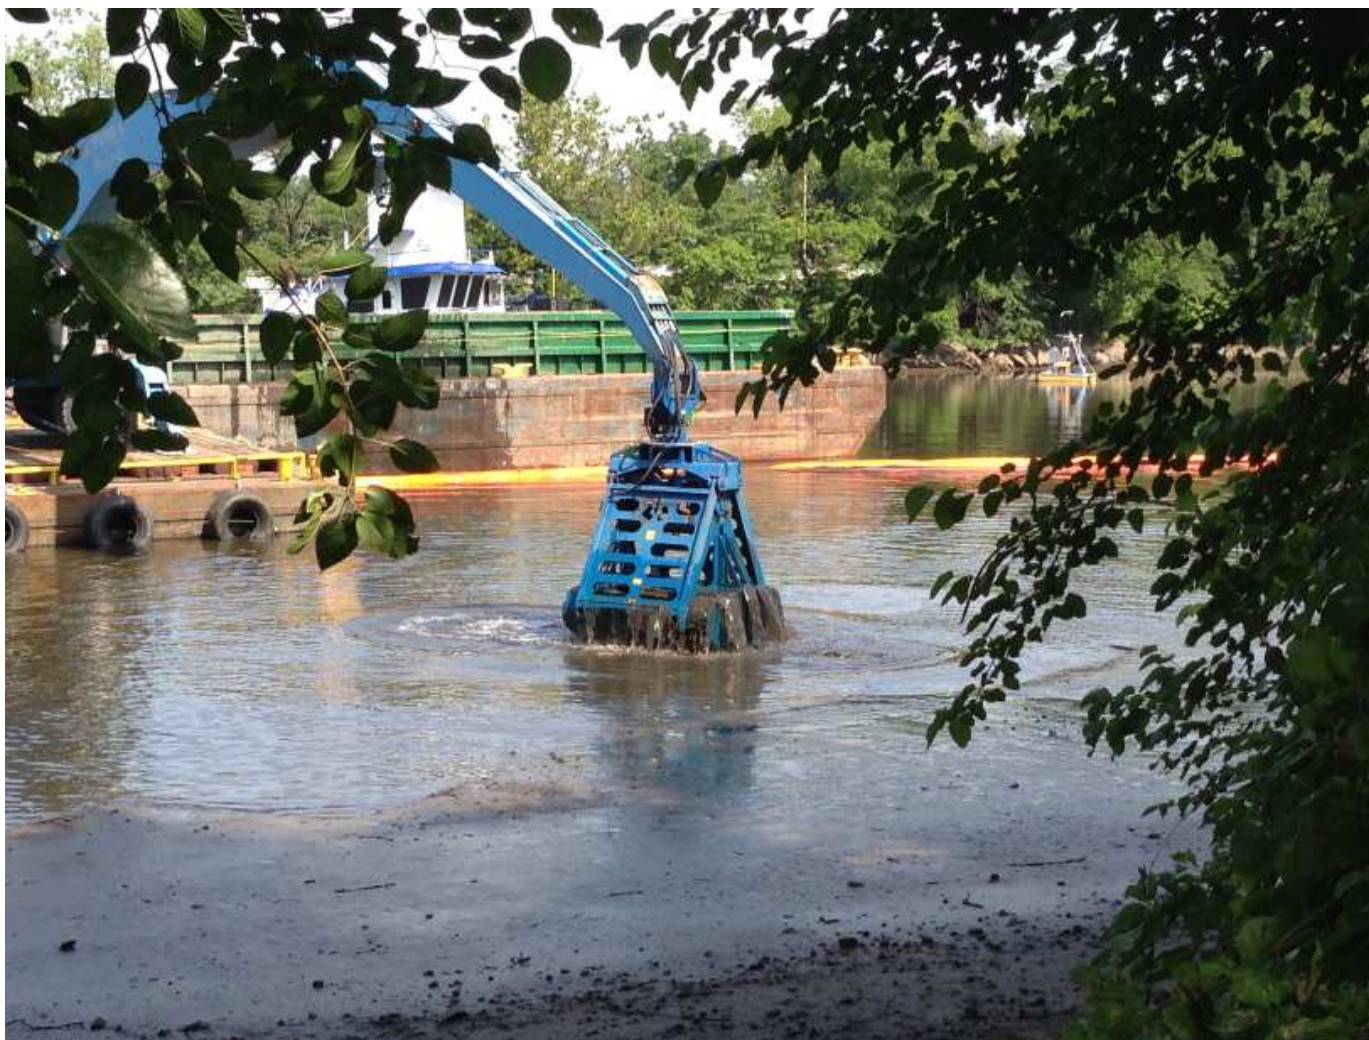
August 17, 2013 Dredging ongoing

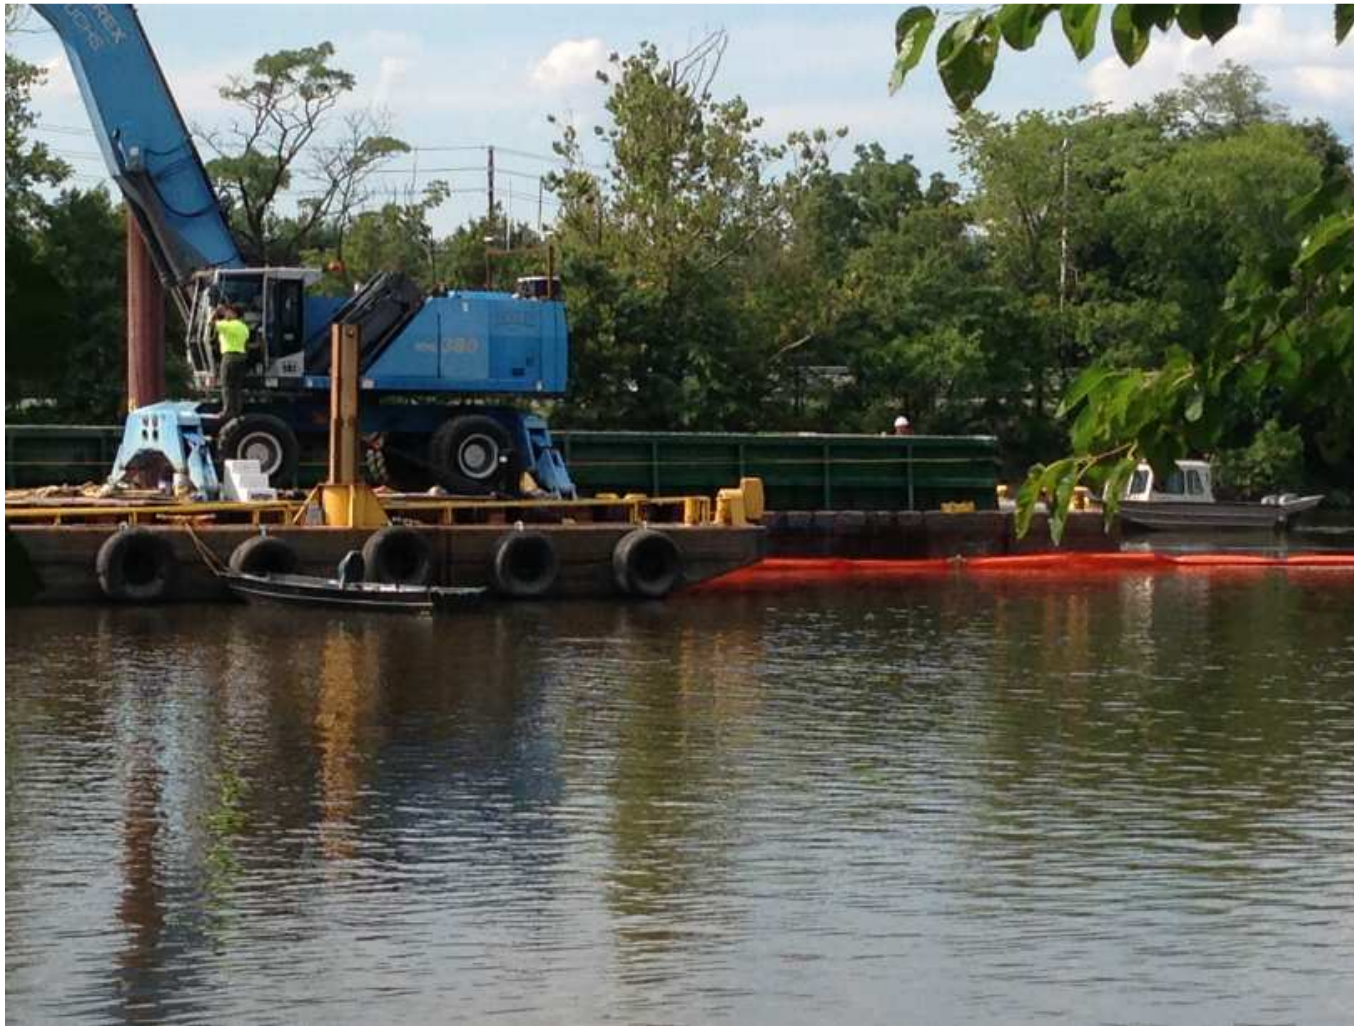
August 17, 2013: Full scow at the end of the day

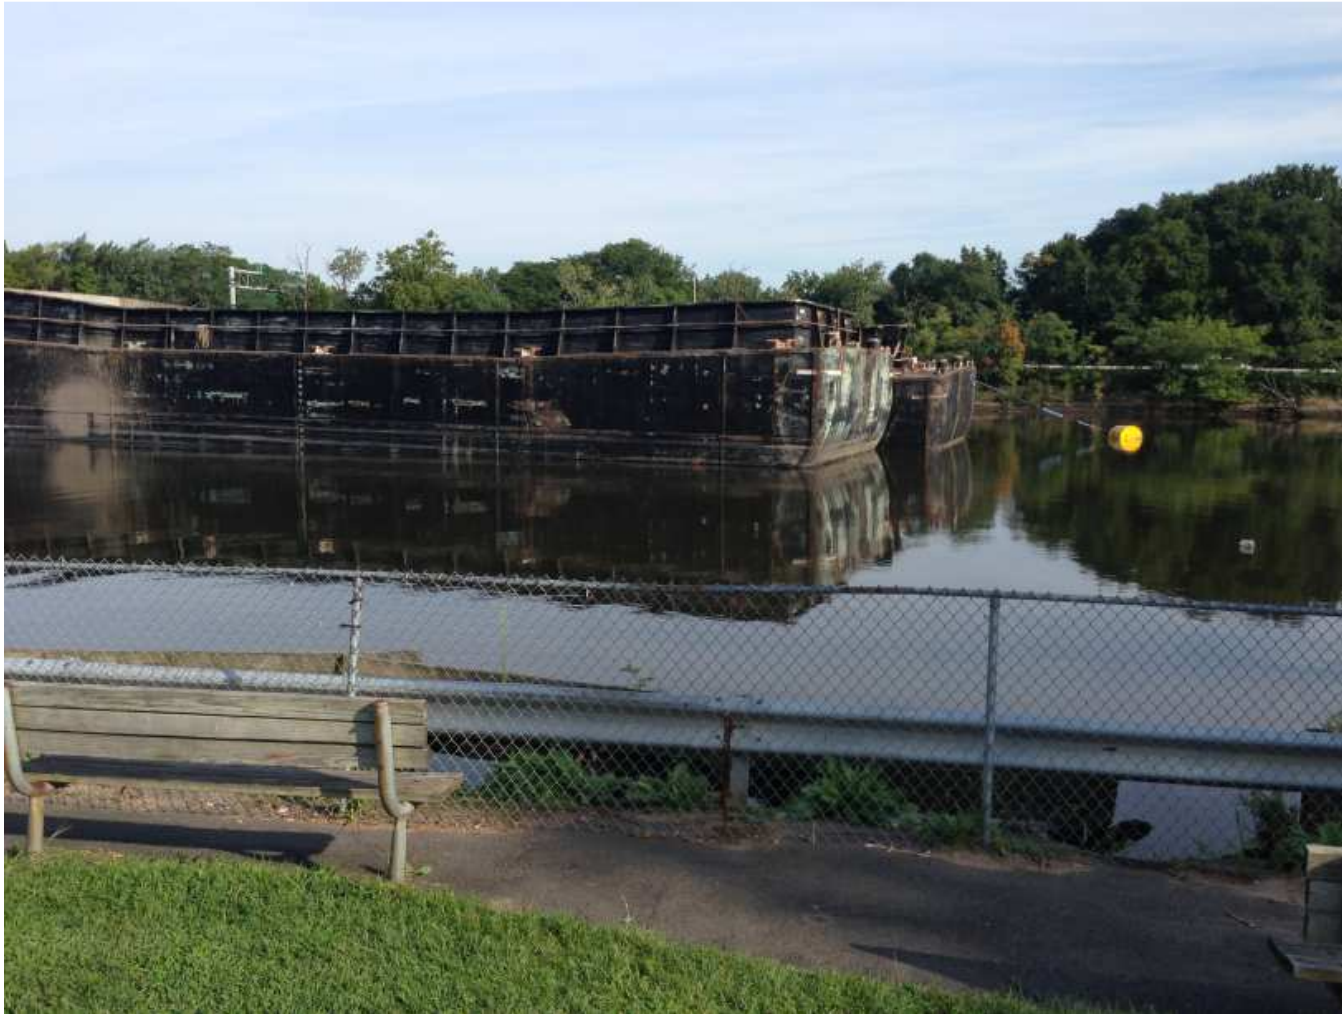
August 17, 2013: Scows moored near fire department boat launch

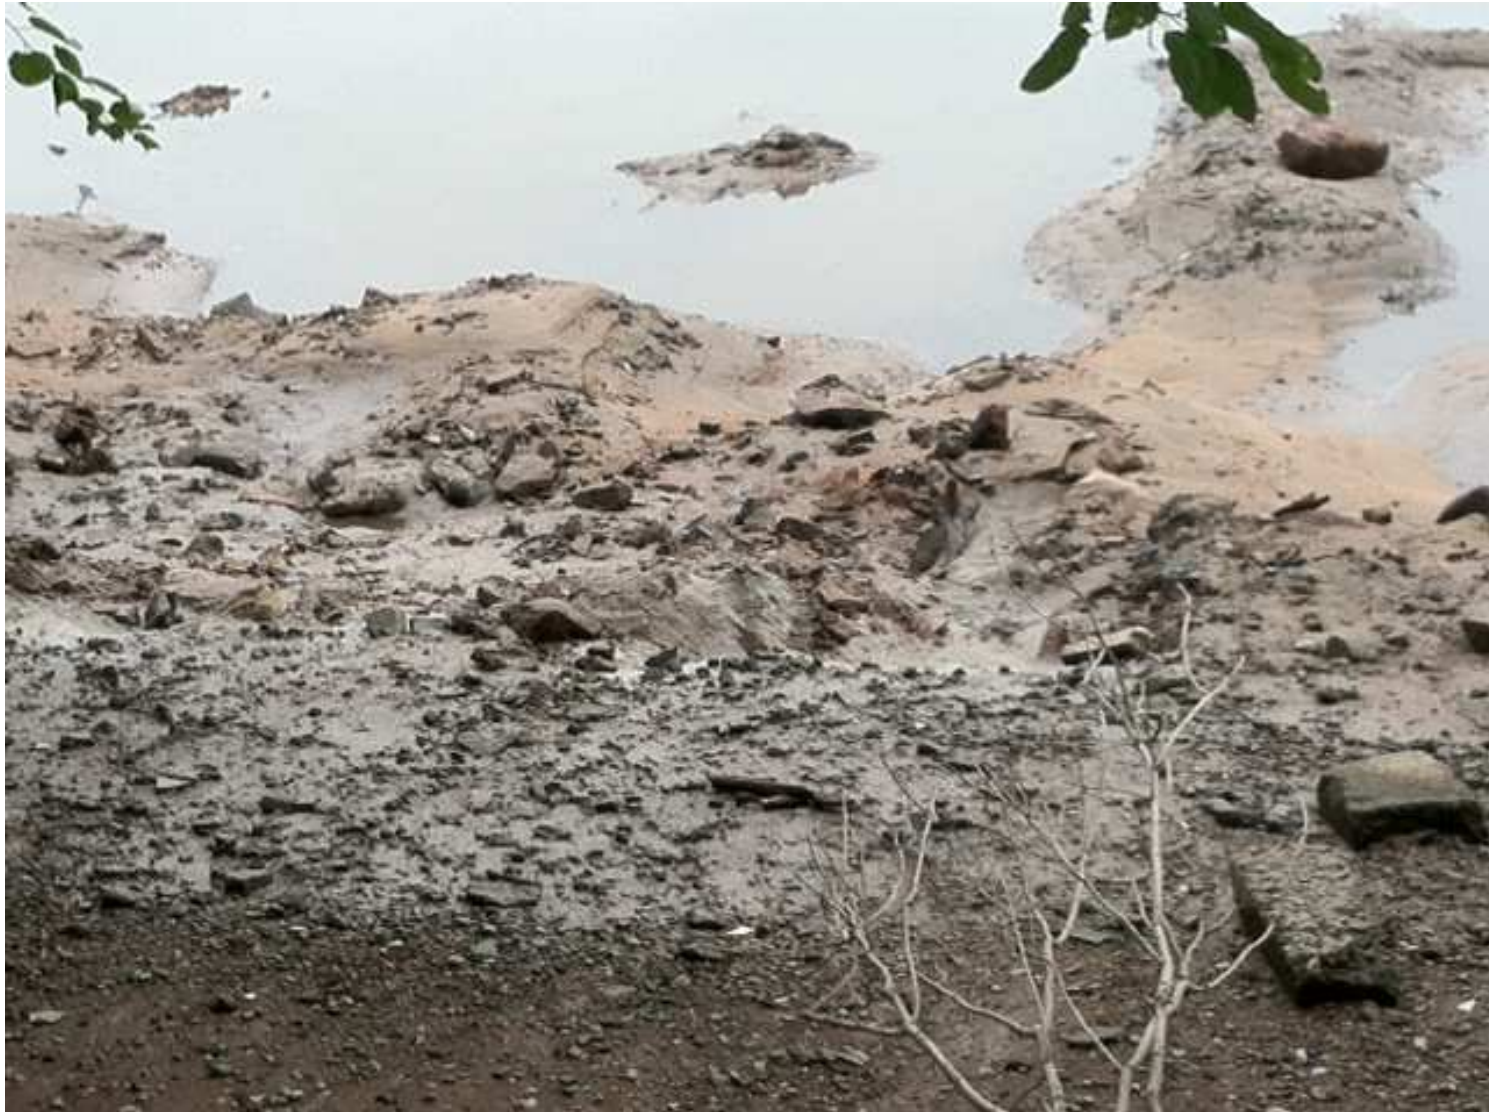
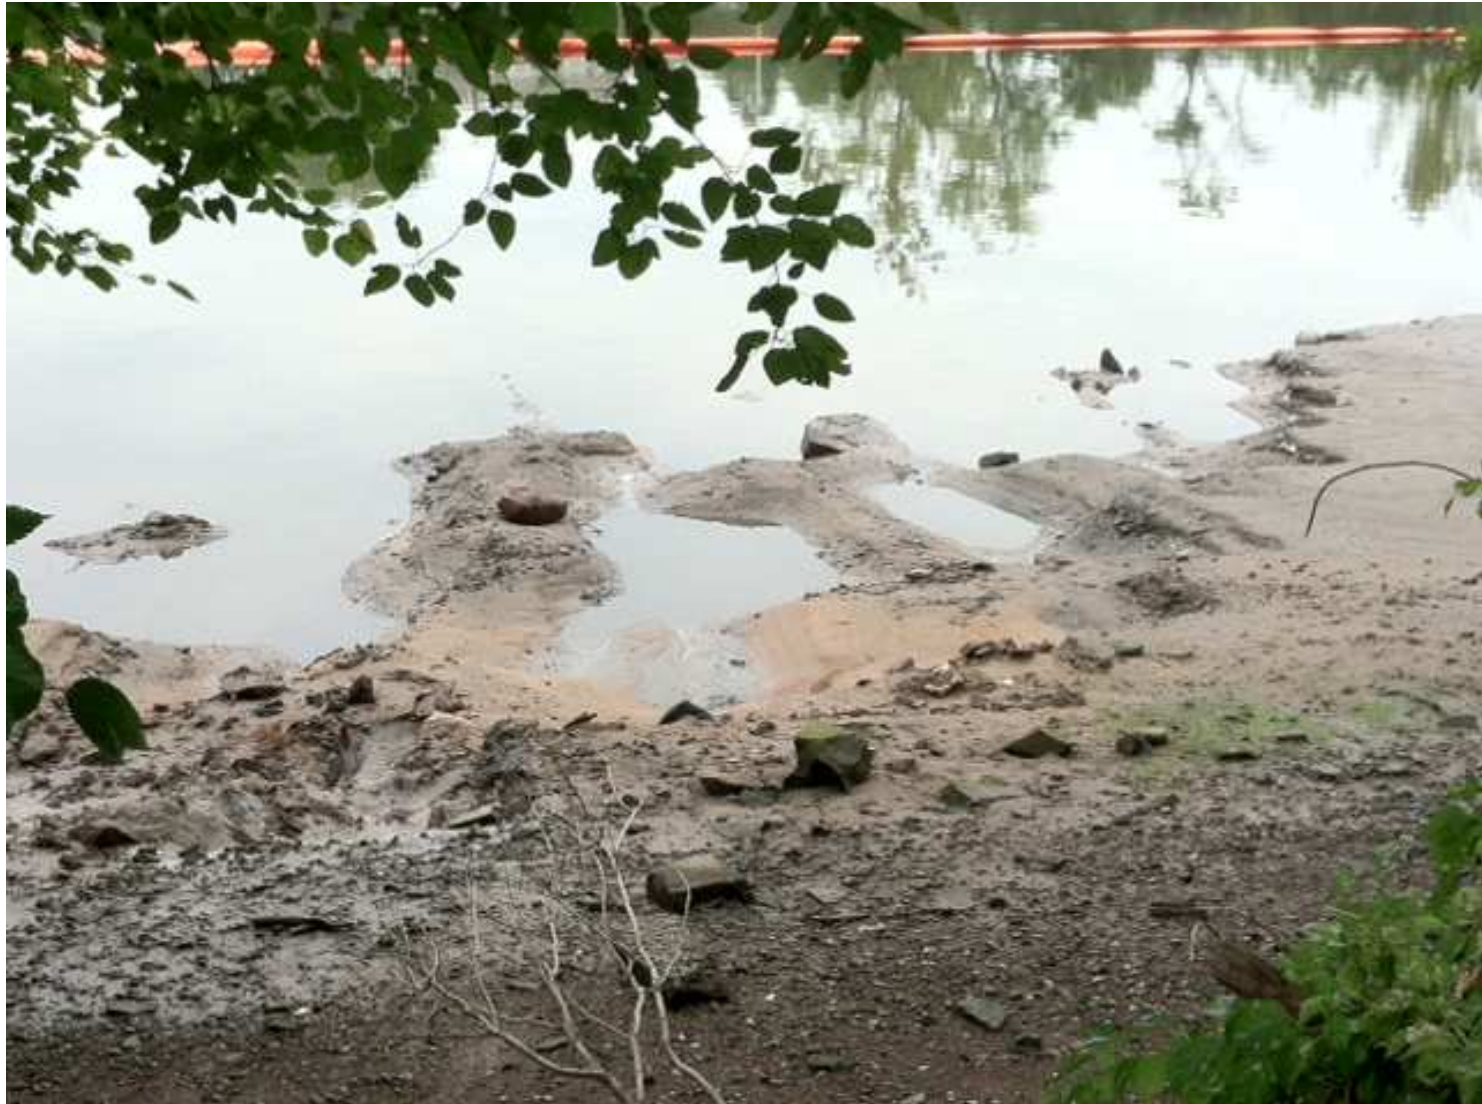
August 19 2013: Shoreline cuts completed this morning

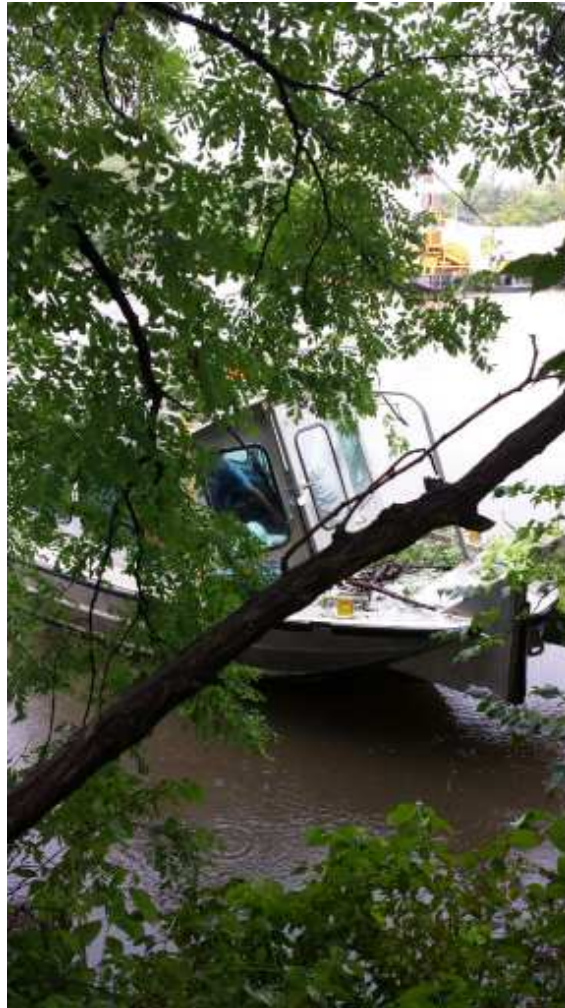
August 22, 2013 Bathymetry survey in Area 1

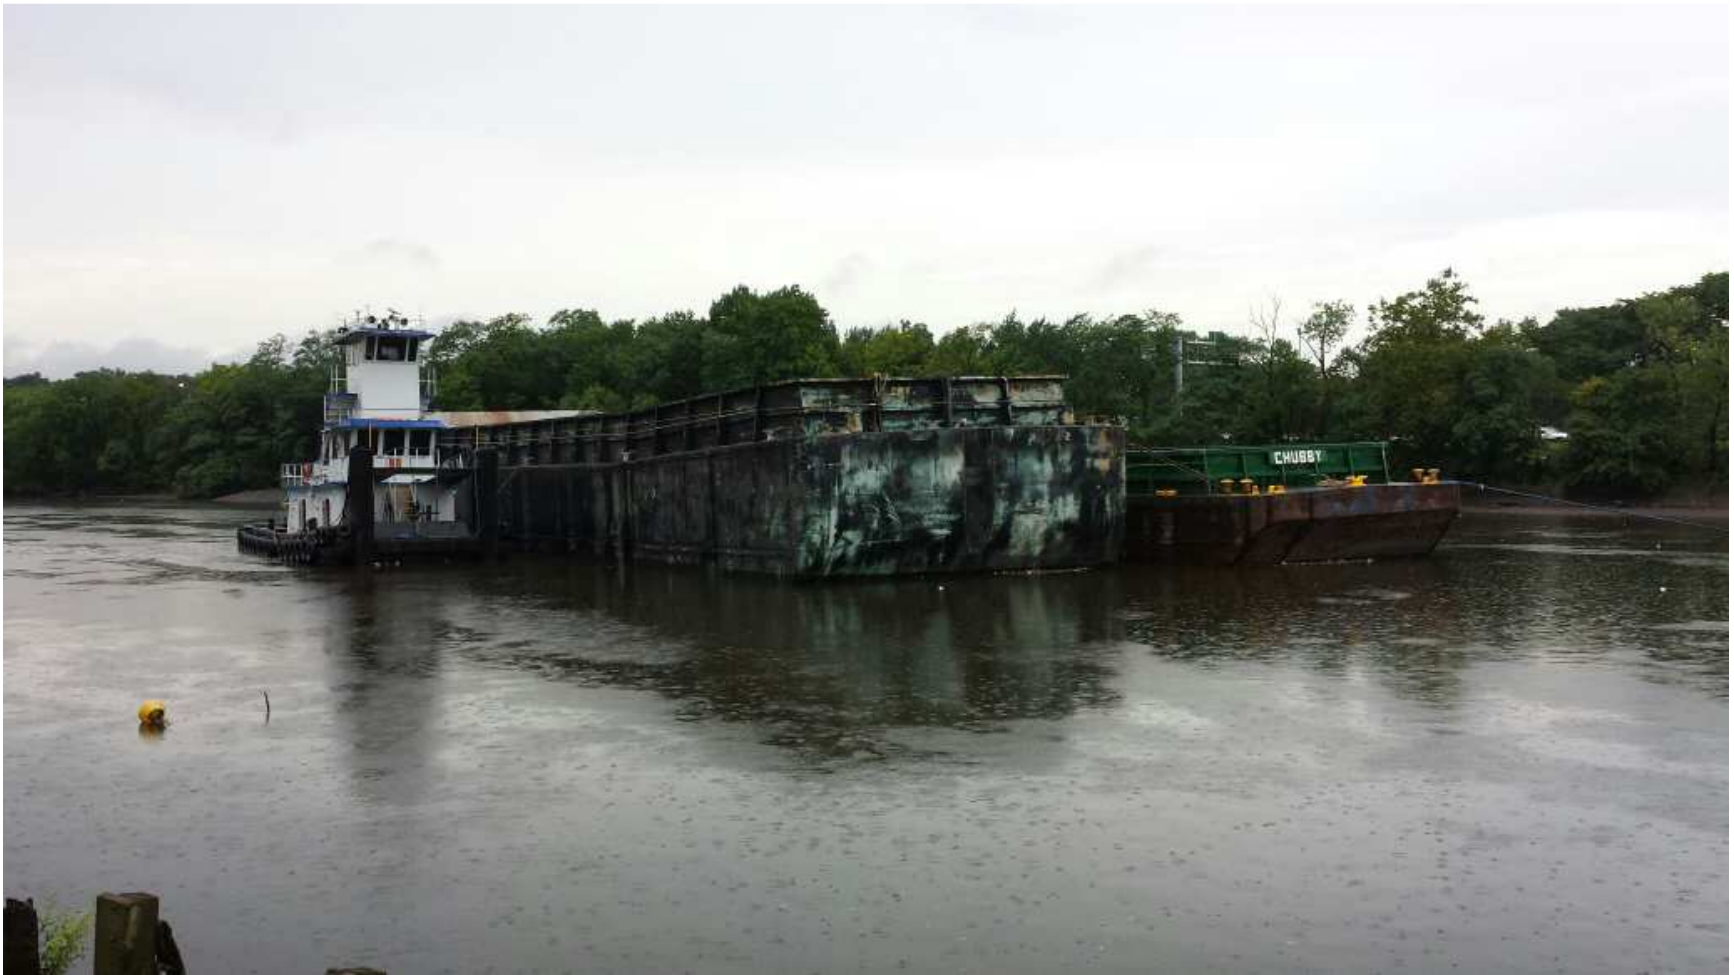
August 22, 2013: Anchored scows

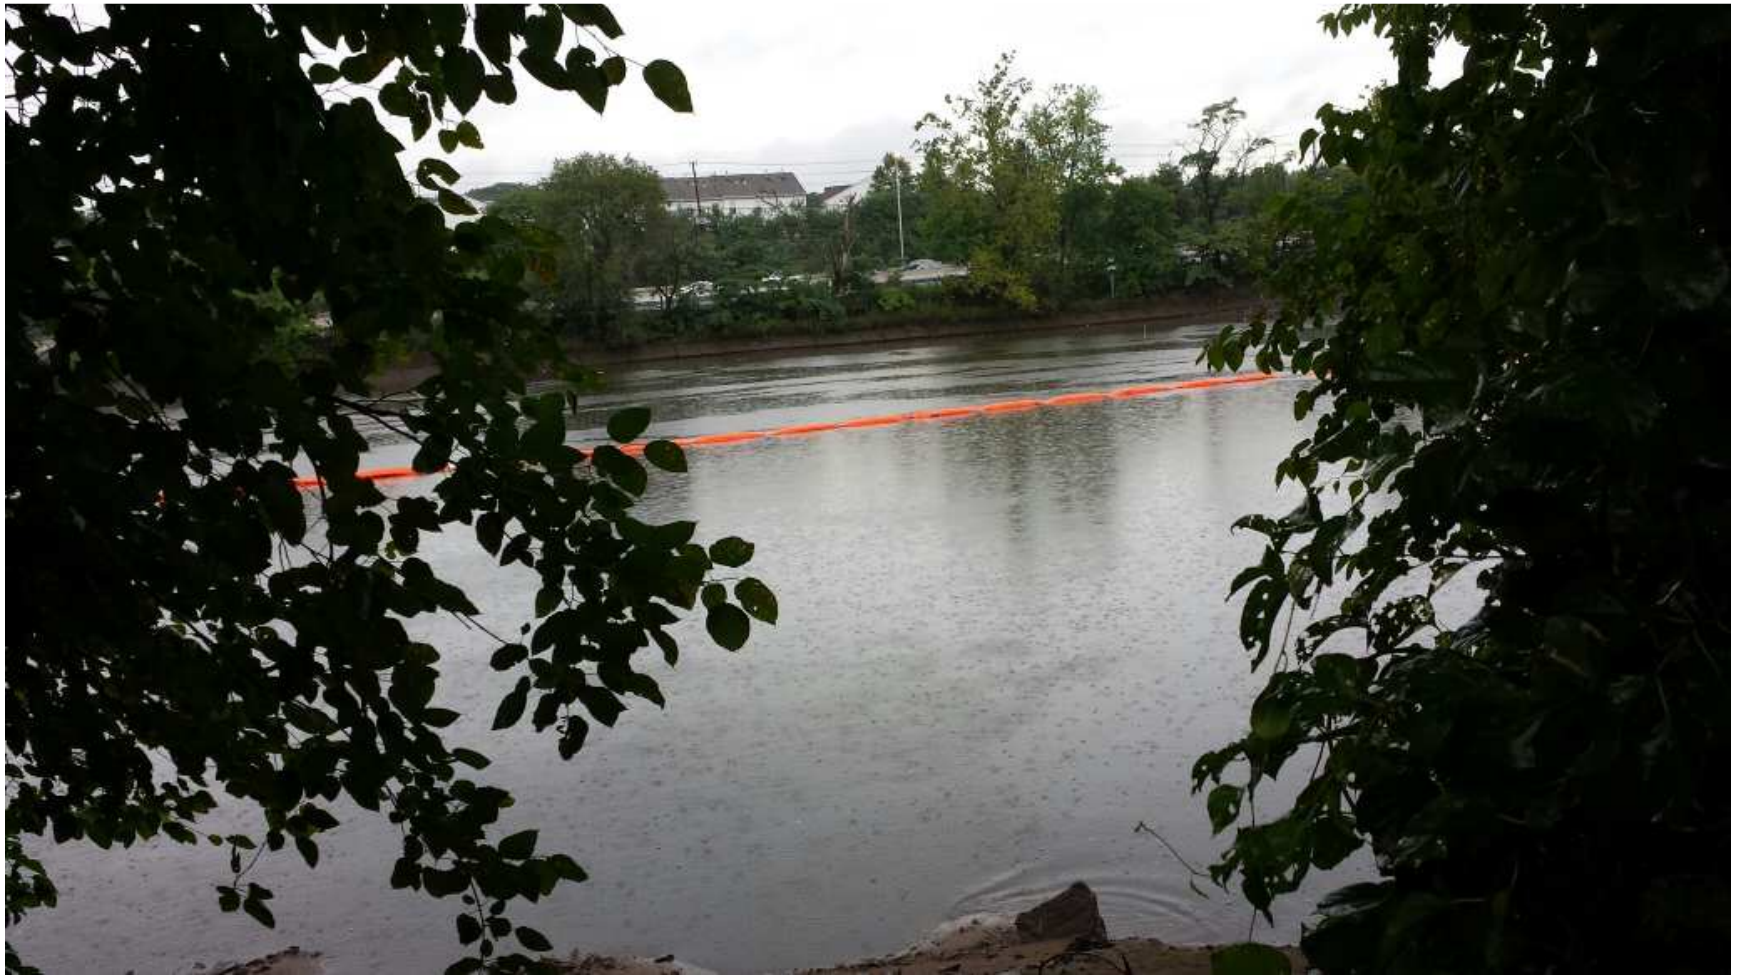
August 22, 2013: Replacement silt curtain in place

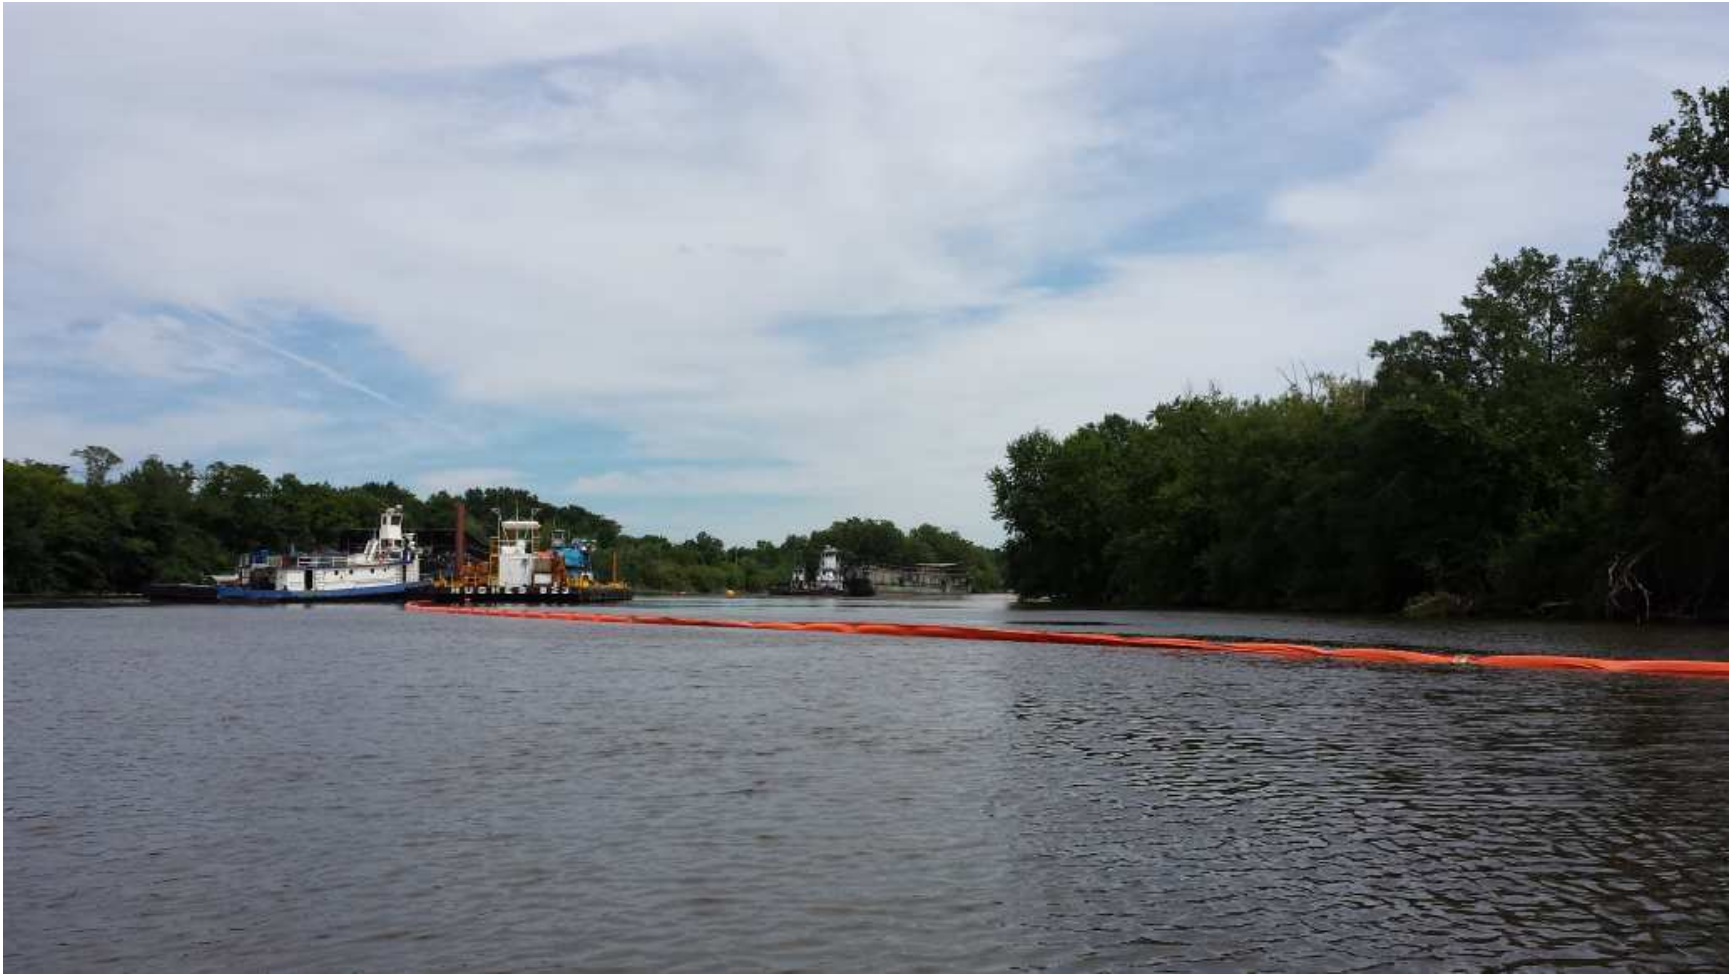
August 23, 2013 Dredging Area 2 with silt curtain still in place from Area 1 dredging

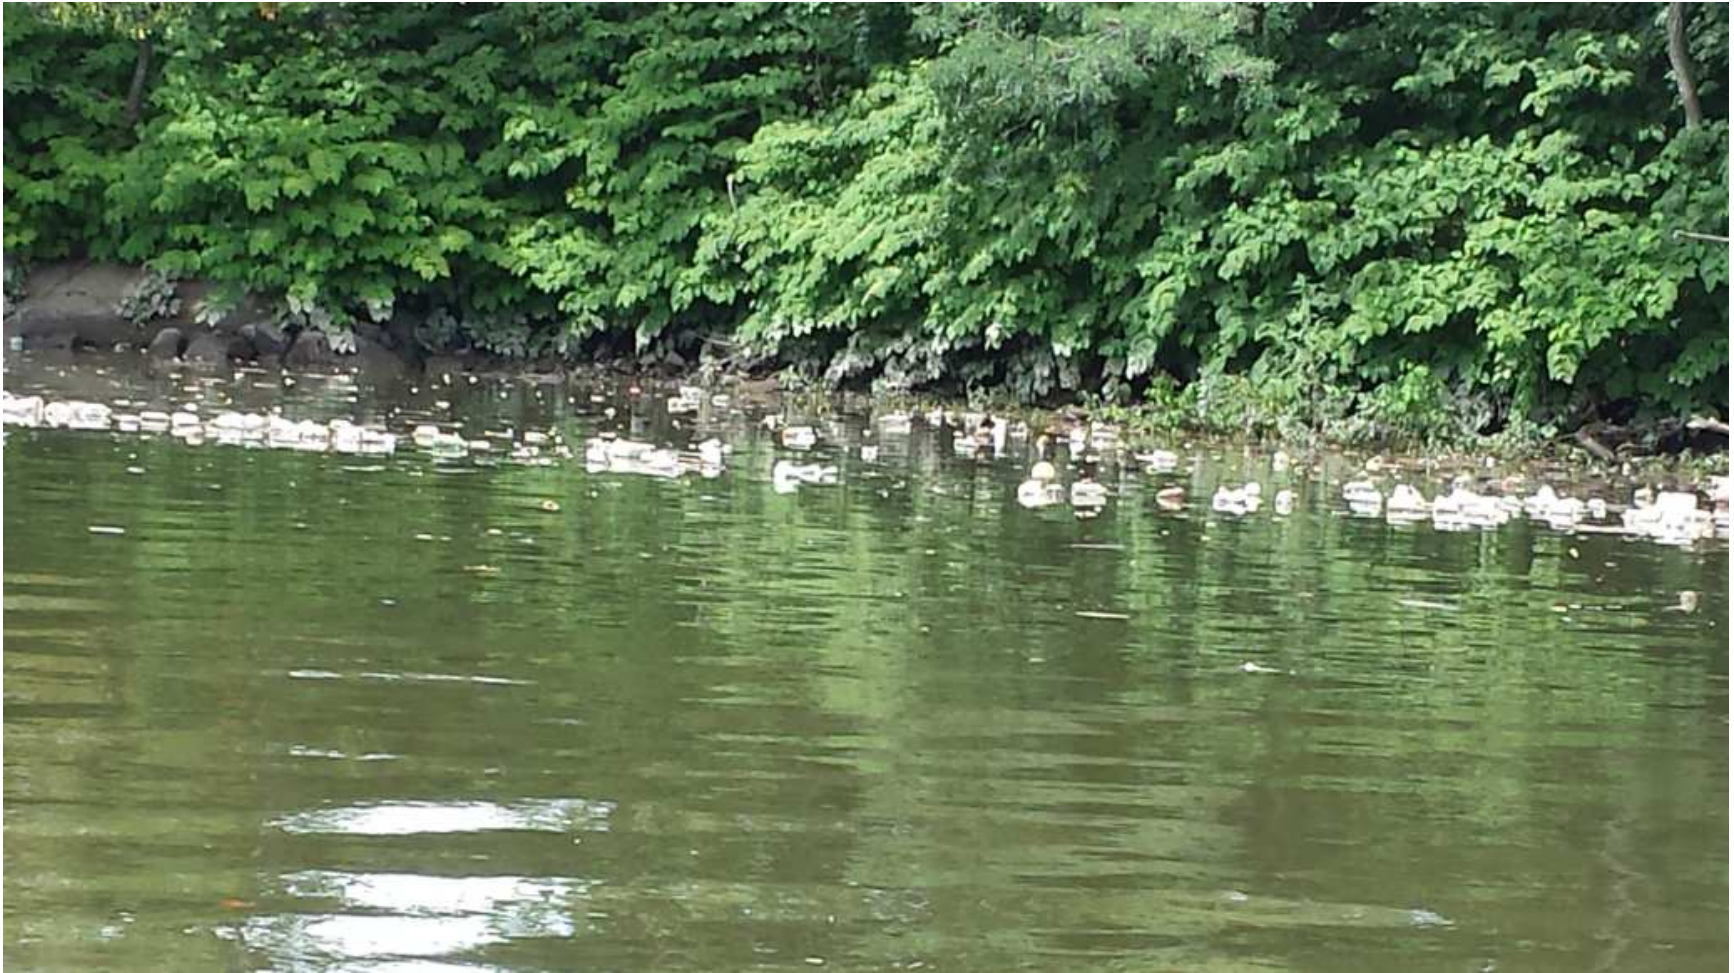
August 23, 2013: Observed trash and debris on river today

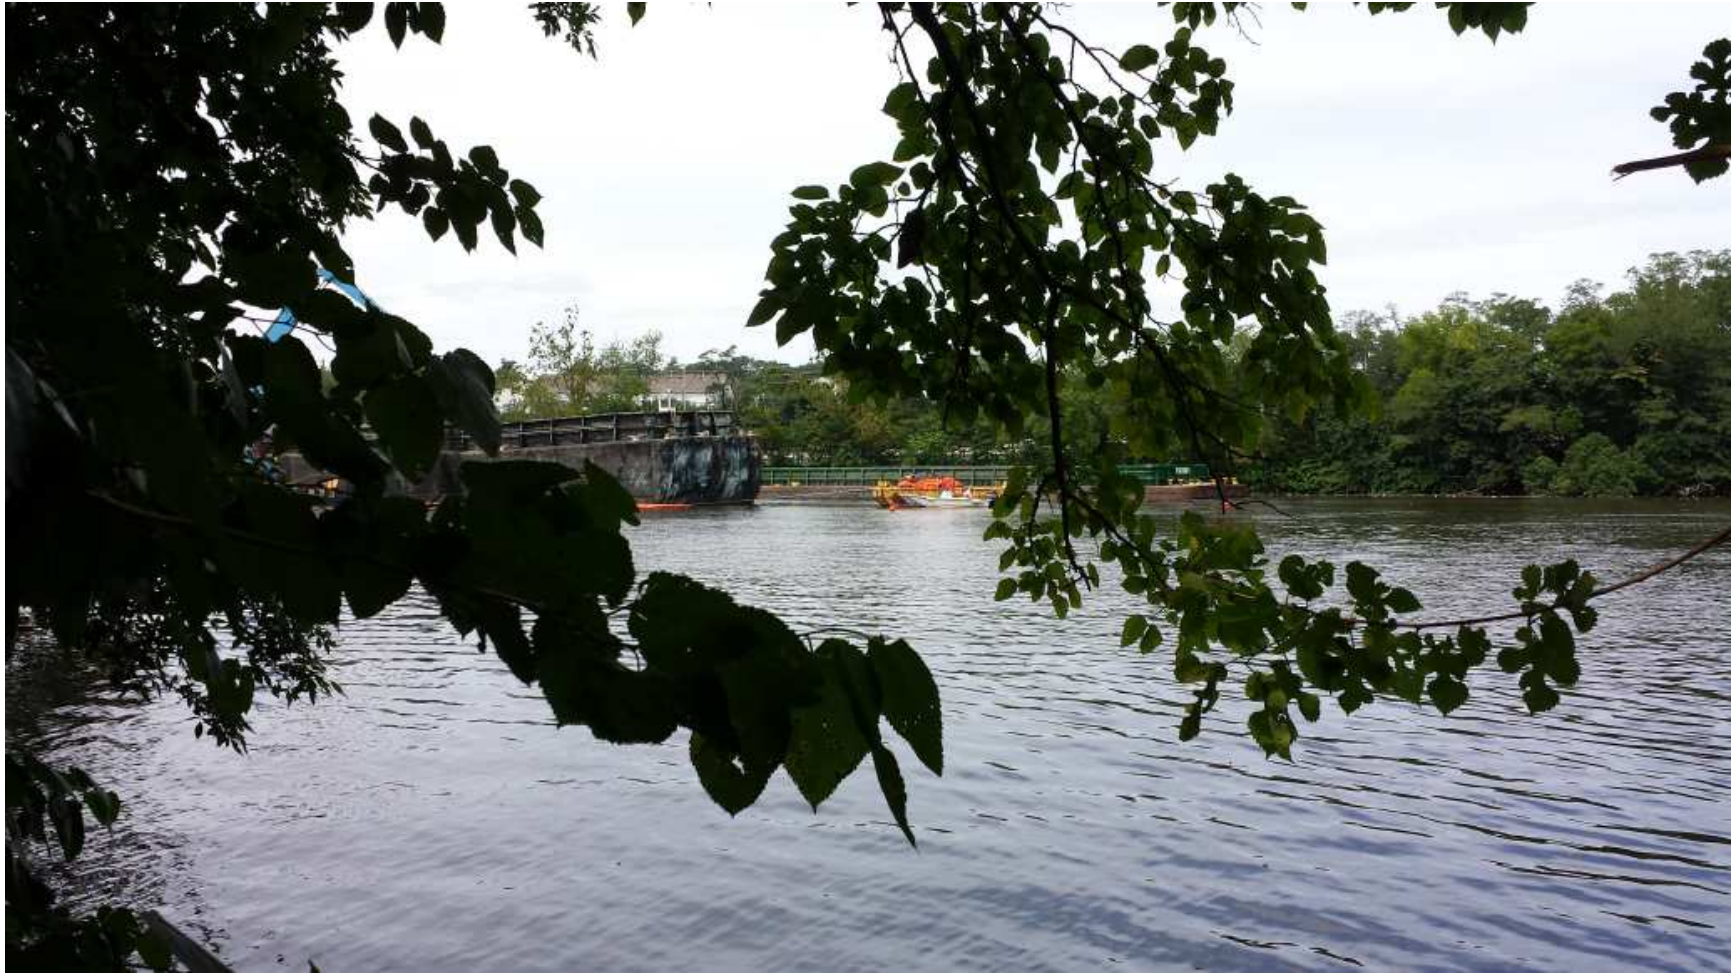
August 23, 2013: Low-profile scow getting switched out

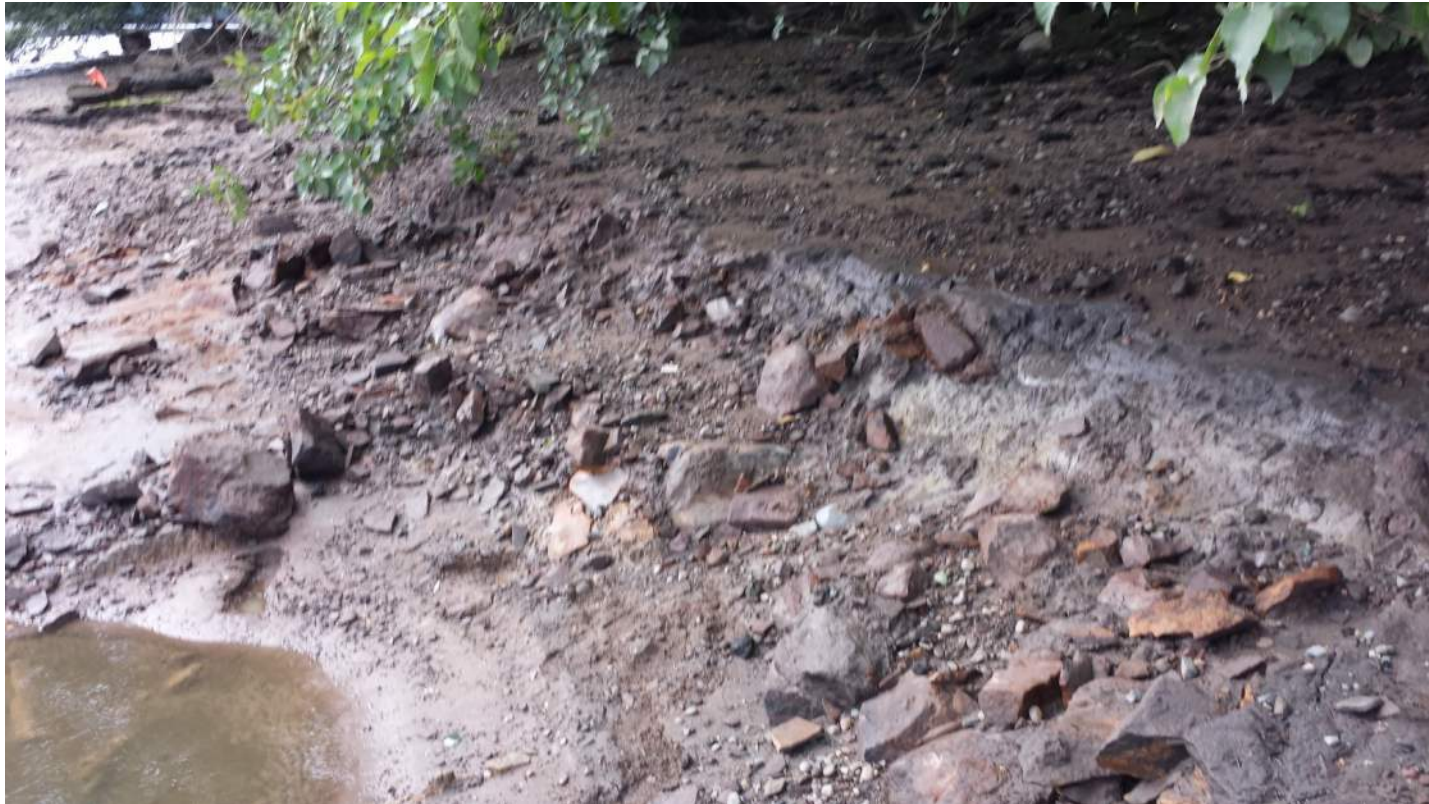
Fractured Rock Outcrop

Same picture as before with outcropping highlighted in red.

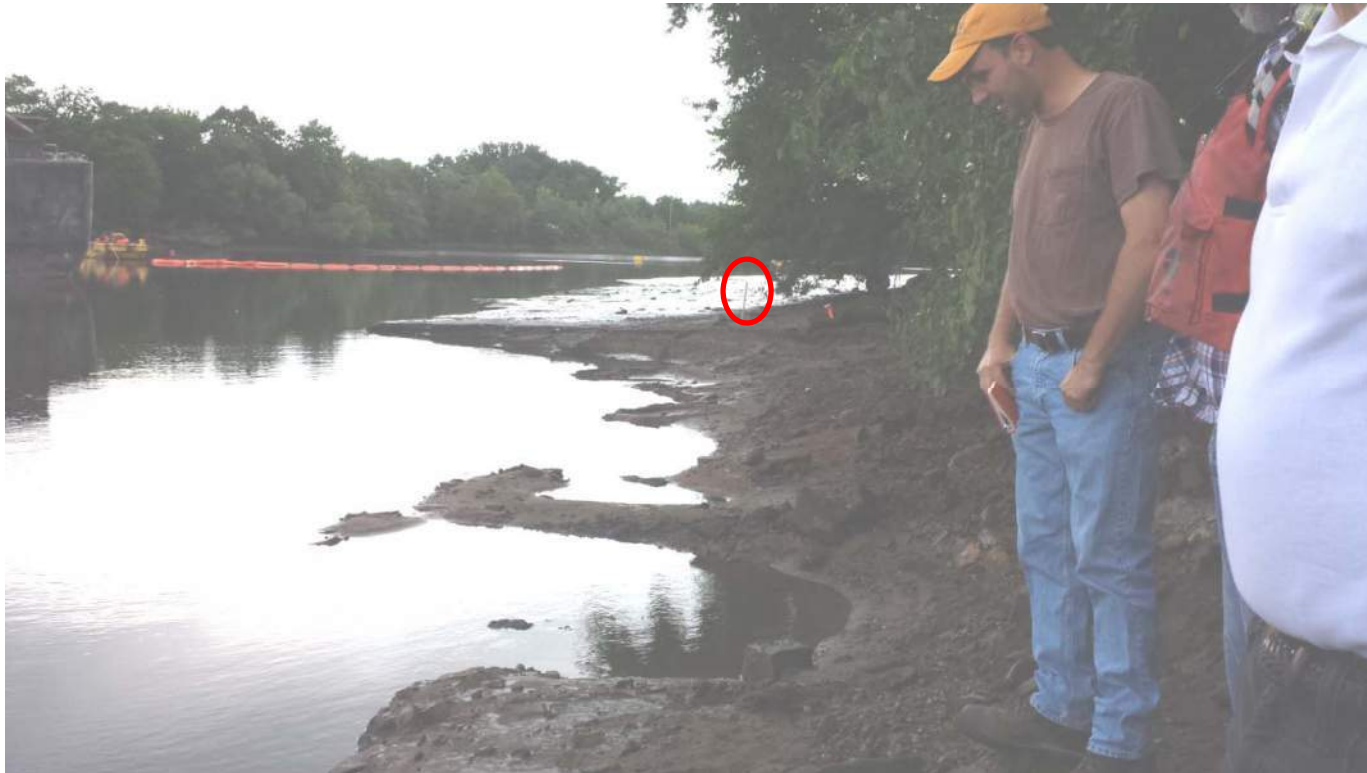
Shoreline Refusal Delineation

GLDD placed 2 stakes to delineate the known extent of the shoreline refusal.

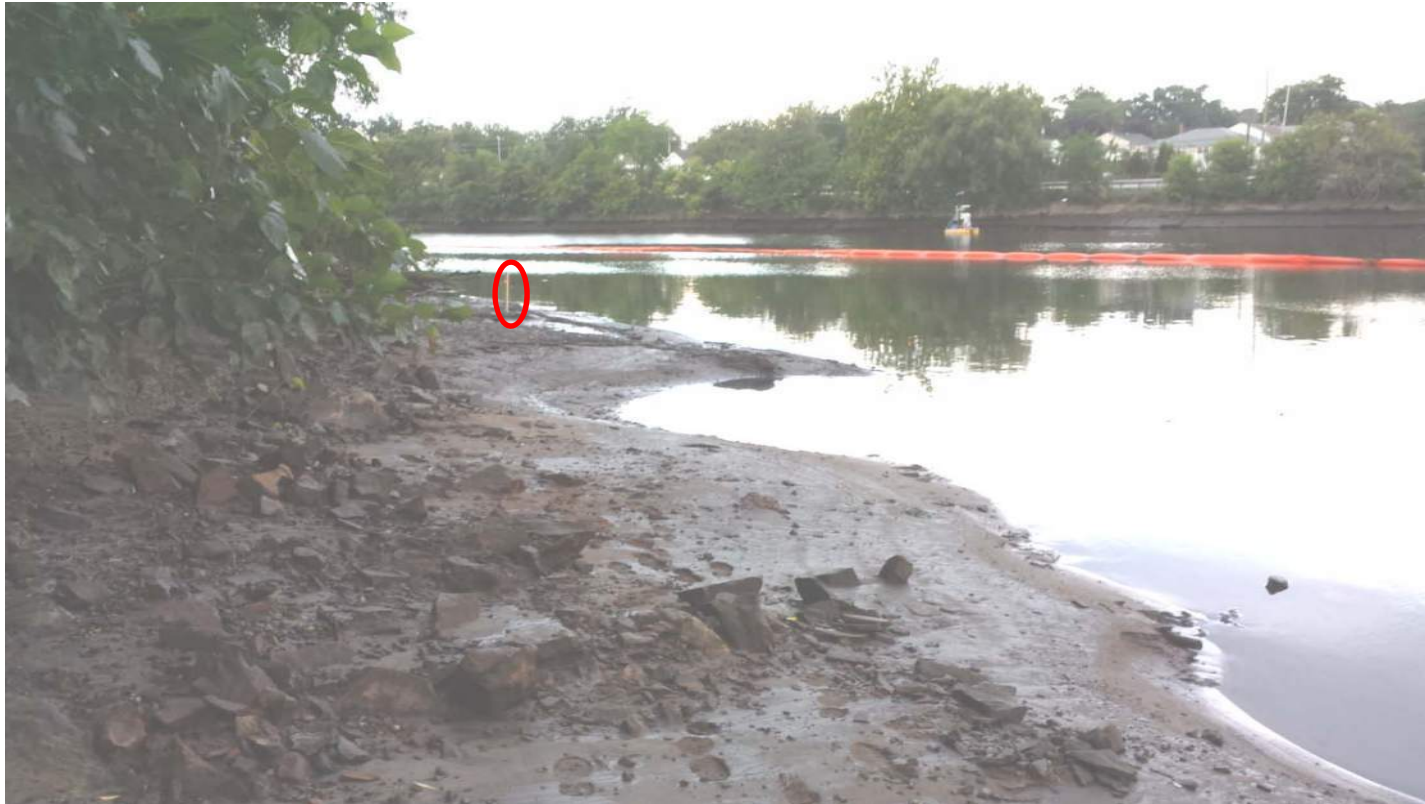
Shoreline Refusal Delineation_2

Stake placed in the opposite direction of the Rt. 3 bridge showing the full extent of the known shoreline refusal.

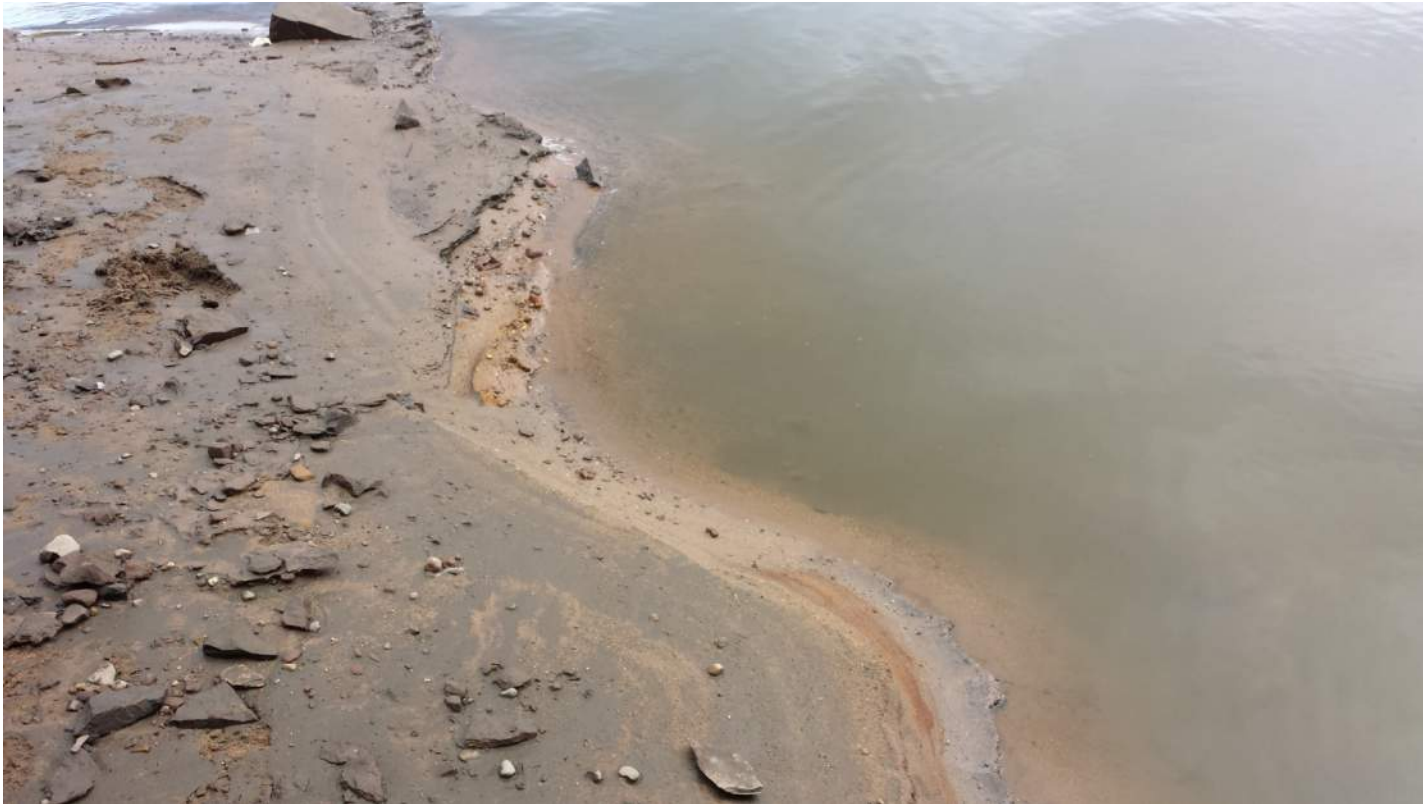
Shoreline Along waterline at Low Tide

Shoreline mostly consists of sand in this area, but is difficult to get to based on the tidal flow and surrounding material.

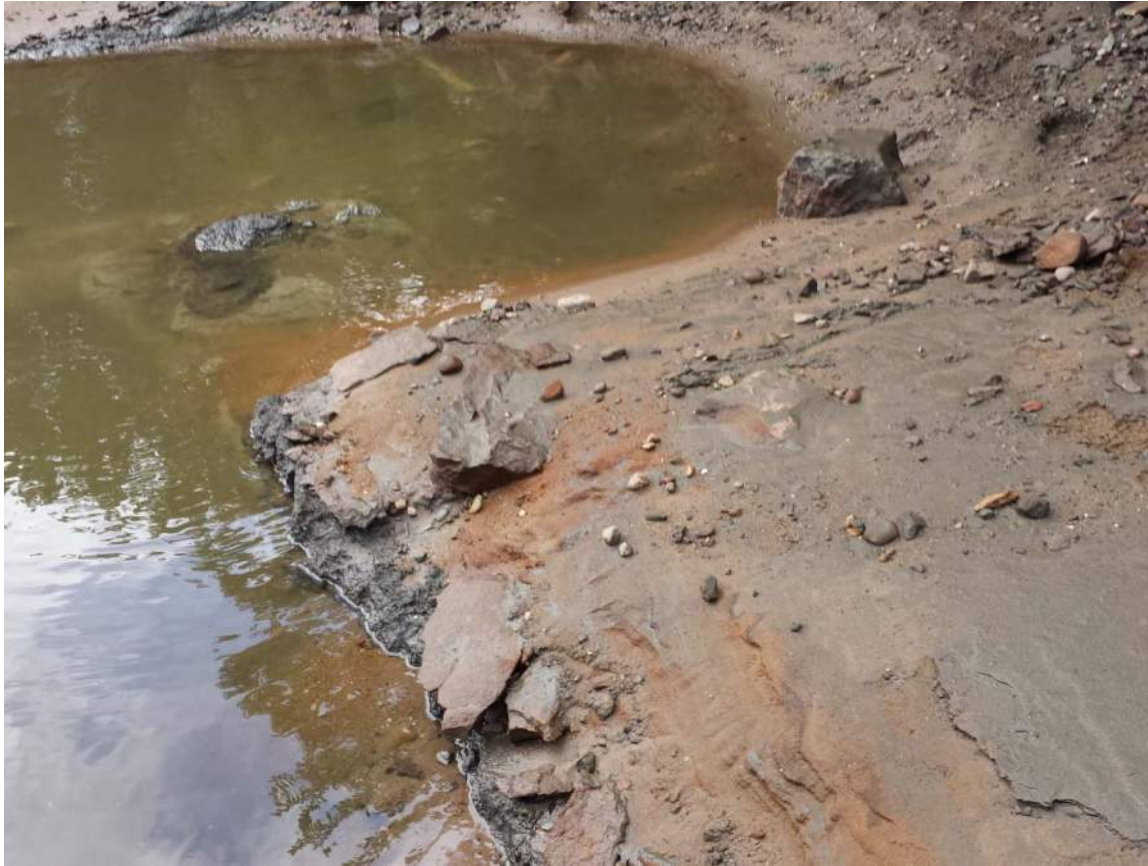
Shoreline along waterline at low tide_2

Shoreline consists of Stiff Clay, sand, and rock.
